Hexcel Research
Reference: 6065

Subject: Contract No. DA-04-200-AMC-477 (A)
Development and Evaluation of a Lightweight Aluminum Honeycomb Case
Monthly Progress Report #7

REPORT OF PROGRESS
JULY 1964

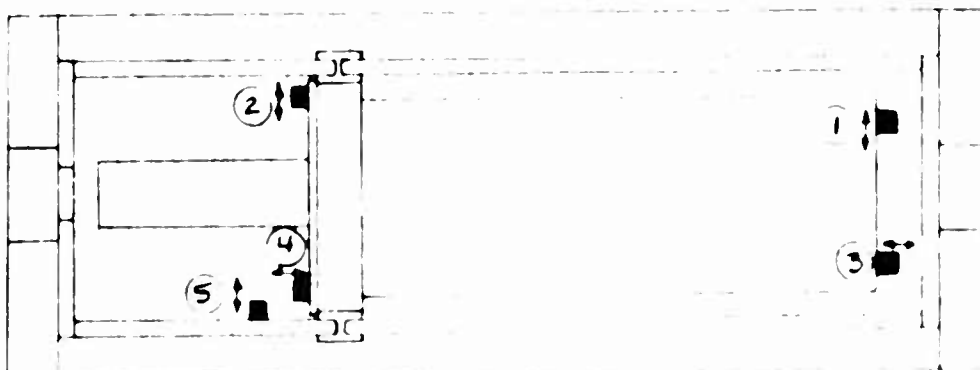
in the acceleration magnitudes for peaks which occurred at similar frequencies on the two Cases were apparently the result of moving Accelerometers #2 and #4 from the internal payload web to the plate attached to the front end of the adapter ring. For all but two peaks, the acceleration magnitudes were lower for Case HXL-5-477 than for Case HXL-4-477. This indicates that there was less magnification on the adapter ring plate than on the internal web.

**Accelerometers for Case HXL-5-477 were located as shown below. The arrows indicate the direction along which each accelerometer measured g values. See Progress Report #6 for accelerometer locations for Case HXL-4-477.

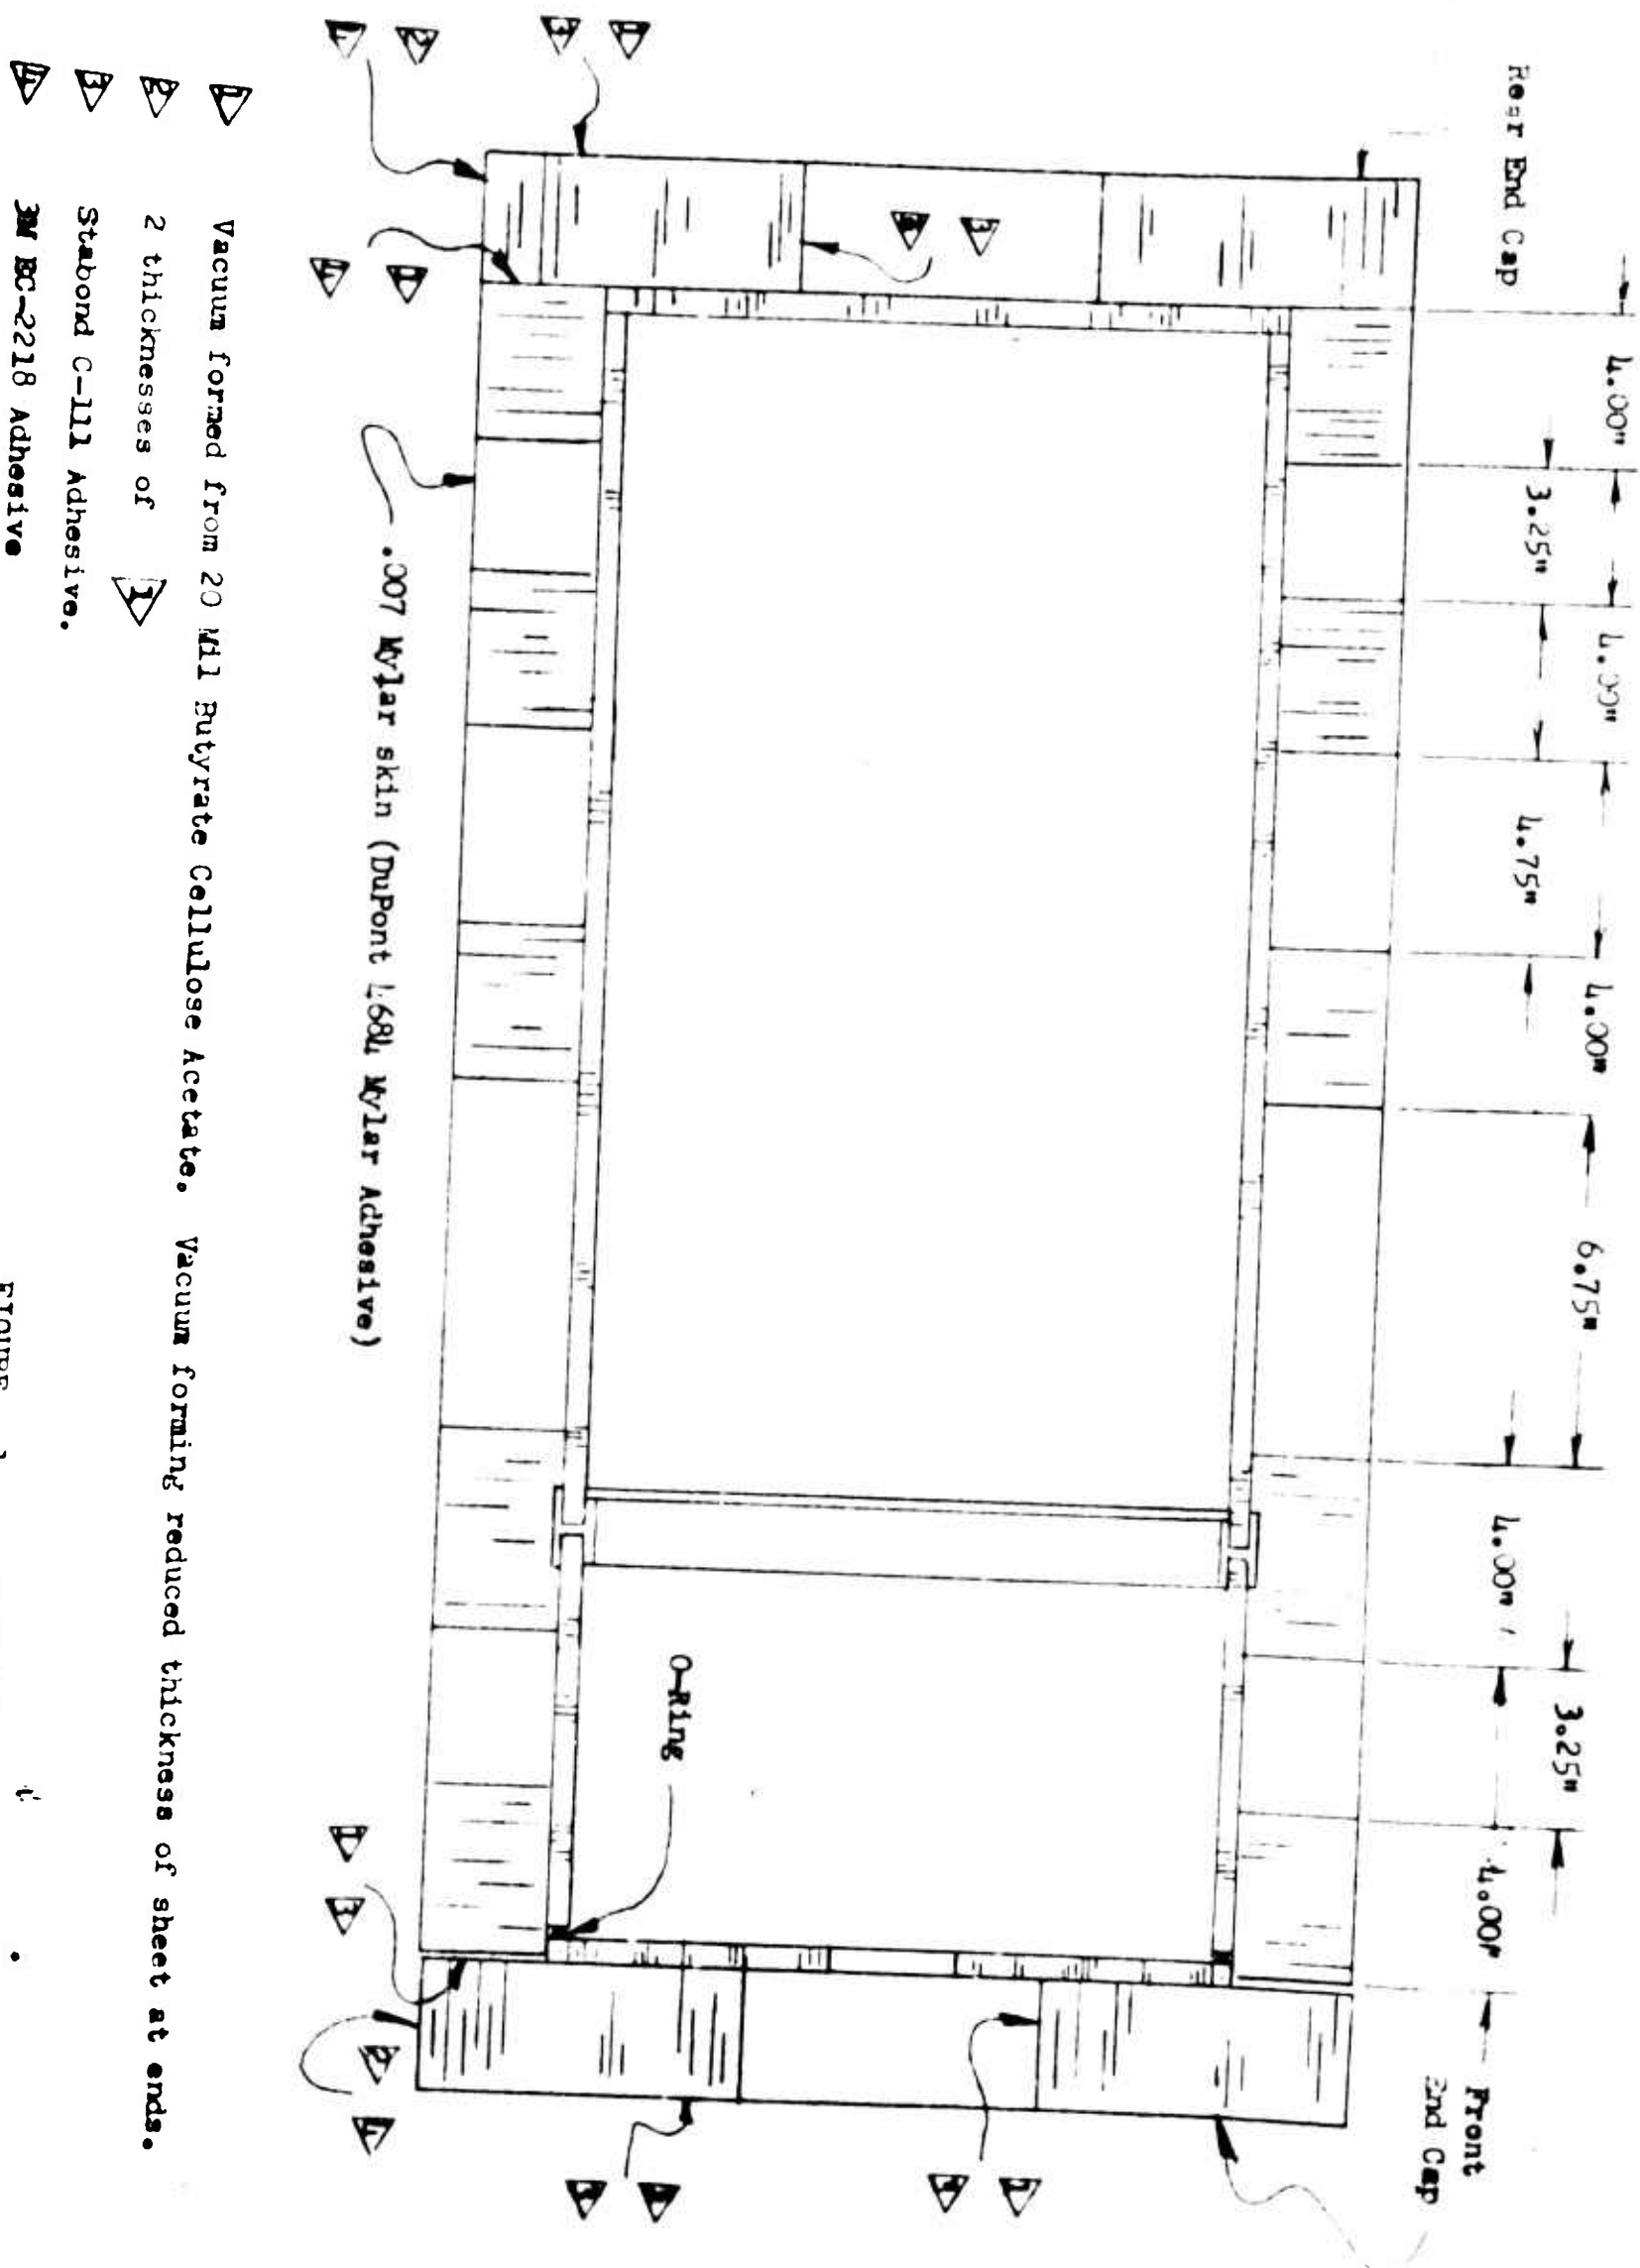
FIGURE 1

A diagram of Case HXL-6-477 is shown in Figure 1. The bond between the plastic faces and the energy absorption core of the end caps was very poor in that large areas remained unbonded after fabrication.

The edges of the front end cap buckled inward $1/4"$ to $3/8"$ all around the circumference. The core was crushed inward (and pulled away from the skin) approximately one inch at two points on the

circumference. There was very little permanent deformation in the skin of the rear end cap or the cylinder other than a slight waviness.

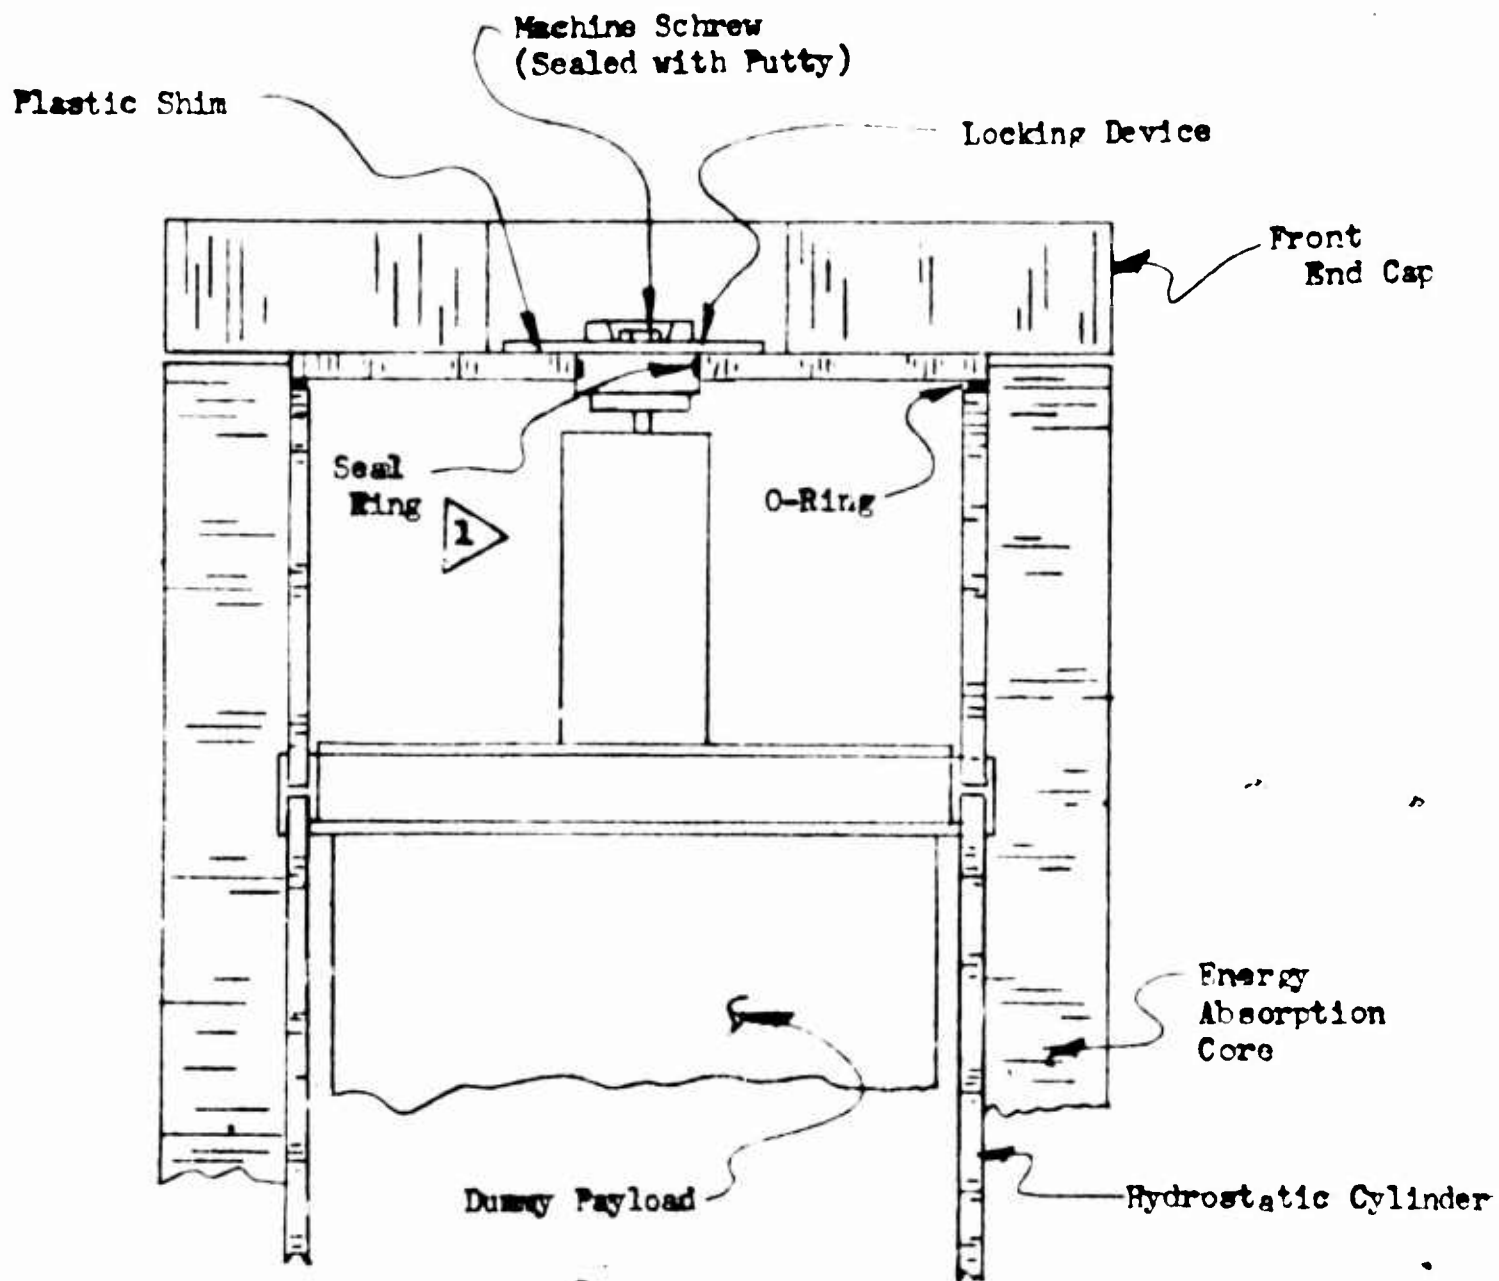
FIGURE 2

It was concluded that the primary source of the leakage into the hydrostatic cylinder occurred by way of the locking device seal ring.

No leakage into the inside of the hydrostatic cylinder occurred during this test. However, leakage past the seal ring occurred during the test on Case HXL-6-477. The probable cause of the different results of the two tests is that the plastic seal ring used during the test on Case HXL-6-477 appeared to be faulty and was replaced prior to the test on Case HXL-7-477.

HYDROSTATIC PRESSURE SEALING CASES HXL-6-477 AND HXL-7-477

The seal ring consists of a Plastic Ring of rectangular cross-section and a rubber back-up ring.

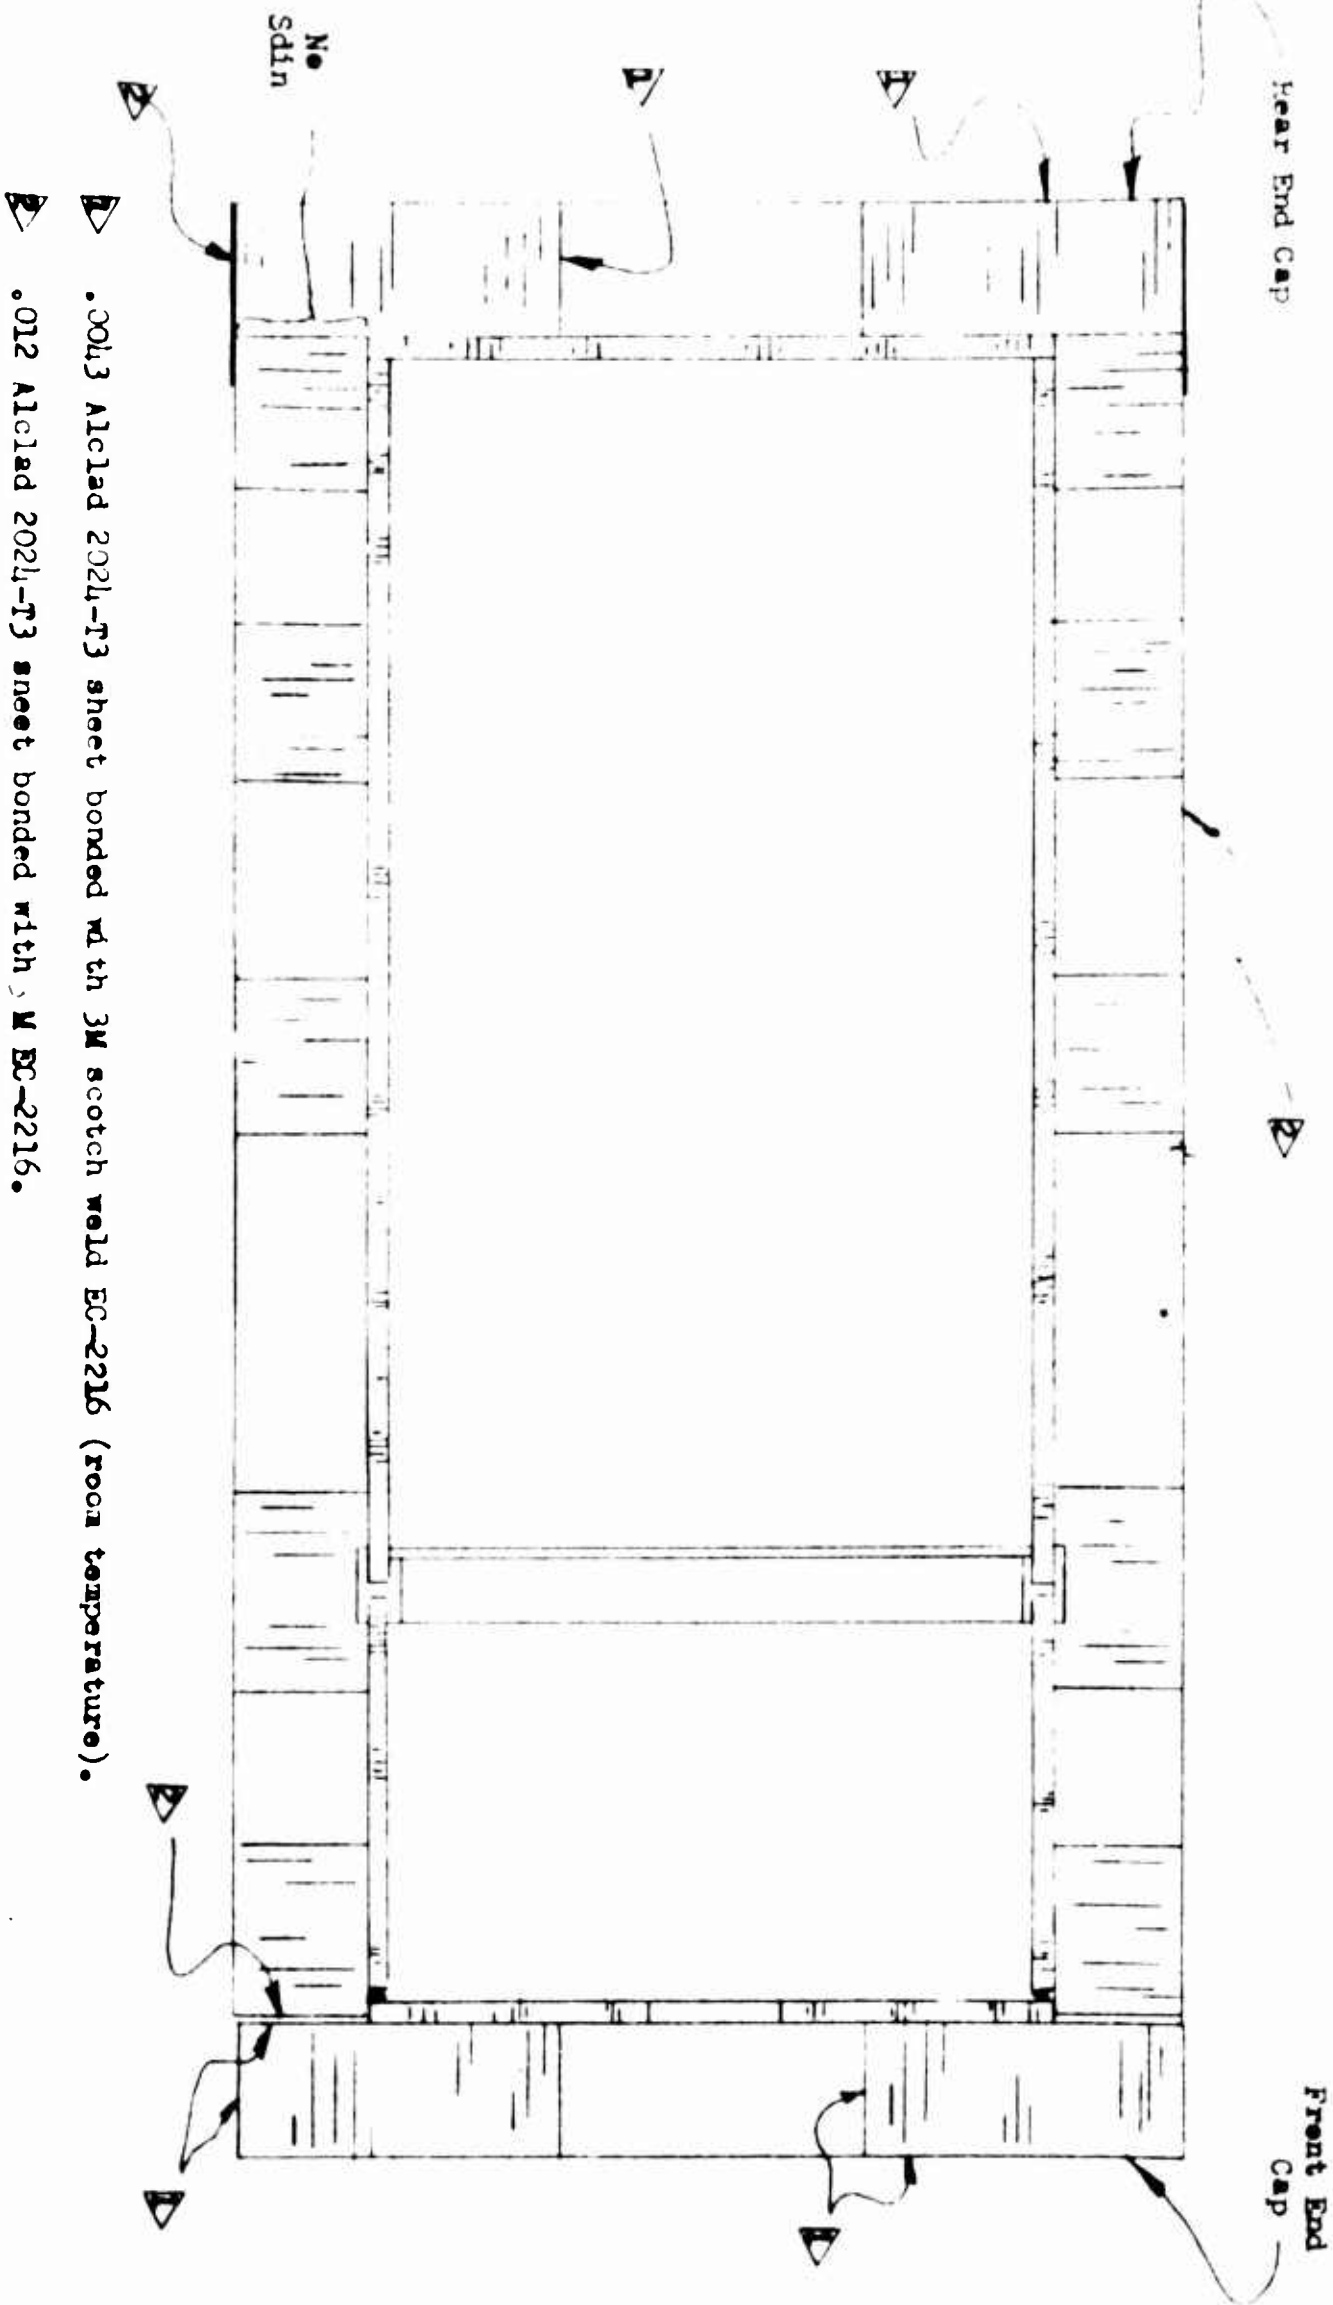
FIGURE 3 CASE HXL-7-477

This Case is basically the same as Case HXL-5-477. Aluminum skin was used throughout. The circumferential cutouts in the energy absorption core extend completely through the core as with Case HXL-5-477, and the core cutout dimensions are the same as those on Case HXL-5-477. A diagram of the Case is shown in Figure 3.

- 4.1 The skin gage was changed from .012 to .0043 in the following places: inner and outer faces and edges of front energy absorption cap; outer face of rear energy absorption cap; inner edge of rear energy absorption cap.
- 4.2 The .012 Alclad 2024-T3 skin on the inner face of the rear energy absorption cap was omitted.
- 4.3 The skin around the edge of the rear energy absorption cap was overlapped onto the cylinder 1/2".

There was no indication of skin buckling or damage to the seams or joints on the inside of the hydrostatic cylinder. A pattern of longitudinal wrinkles occurred in the energy absorption cylinder skin over each circumferential core cutout. The wrinkles were approximately uniformly spaced around the circumference of the cylinder. The edges of the front and rear end caps had similar patterns of longitudinal wrinkles extending around the circumference of the caps. The circumferential skin joints opened intermittently.
